DISTANT RUNNER RESULTS

A 5 Event High Explosive Test Series
Involving U.S. Air Force 3rd Generation
Aircraft Shelters

Robert A. Flory
Defense Nuclear Agency

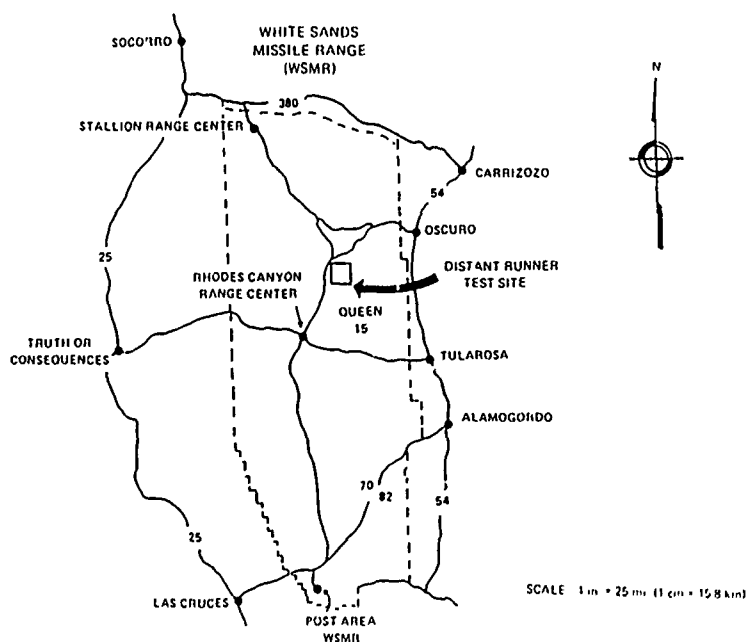
Figure 2

The general testbed location was in the northern portion of the White Sands Missile Range in the Queen 15 area. This site was chosen specifically for its high water table of 6-10 feet below the surface. This geology represented the typical worst case high water table geology for the European Theater.

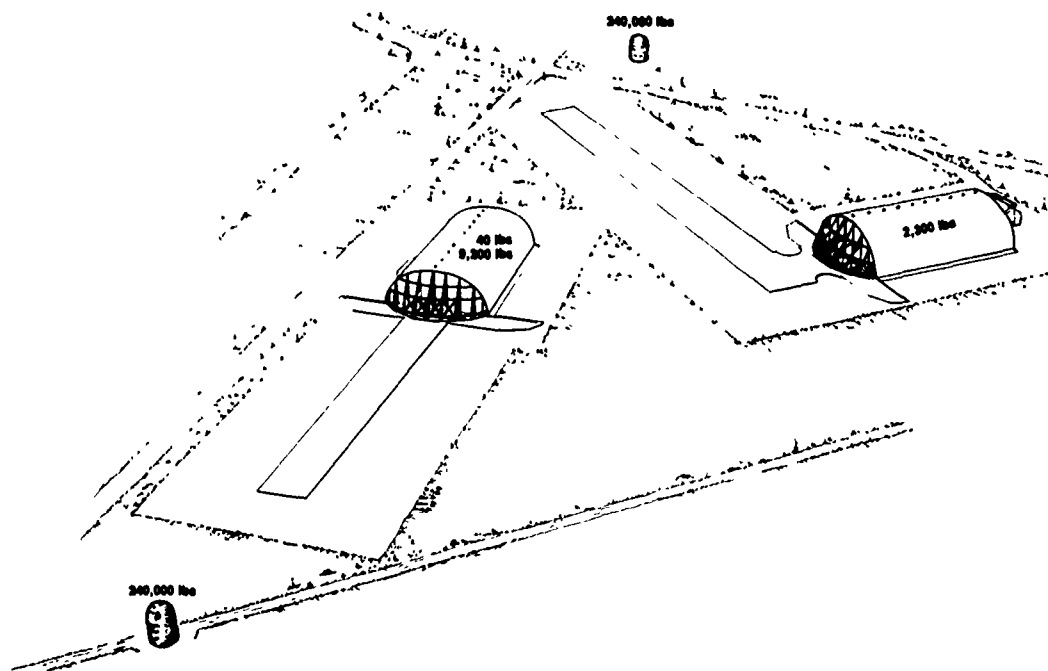
TEST BED CONFIGURATION

Shown in Figure 3 is the DISTANT RUNNER testbed. The two aircraft shelters depicted here were constructed from drawings provided by USAF Europe. The shelters were built exactly to those specifications with the following few minor exceptions - the footings were 2 feet wider than usual due to local soil conditions. No electrical work was done and the door opening mechanism was not installed. The orientation of the shelters was designed so that the required information could be obtained from the minimum number of external events. The runways/taxiways were also of standard USAF construction. The angled taxiway was designed to allow for a range of damage from both ground shock and debris damage. The other taxiway leading directly into the shelter was also configured to measure a range of damage levels and was oriented in line with ground zero. Because of this orientation, the damage mechanisms were expected to be different with more buckling expected.

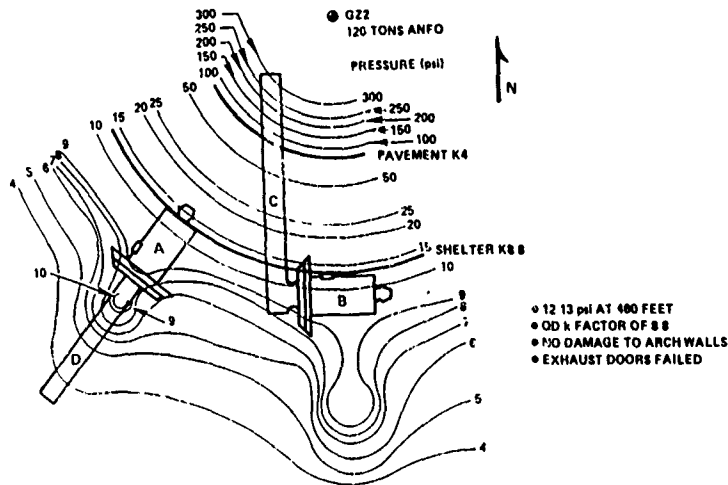
As shown in Figure 5 the actual free field airblast pressure environment was slightly lower than predicted. Measured pressures at the edge of the shelter averaged 13 psi. Free field positive phase overpressure impulses were also lower than desired, averaging 404 psi-ms (2785 kPa-ms).

DISTANT RUNNER 2 SEP 81 - BLAST ENVIRONMENT

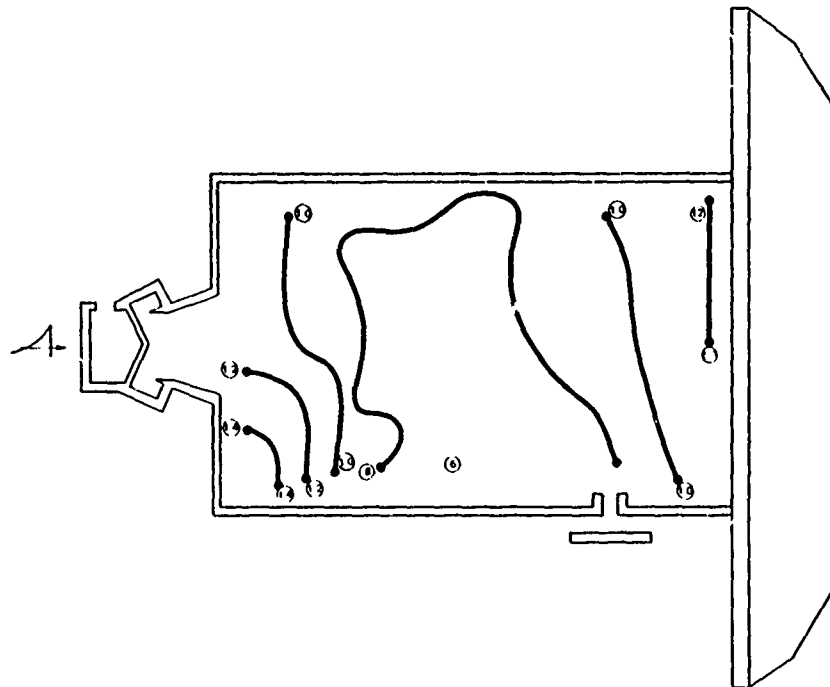
Figure 6

The next two Figures depict the peak internal overpressures. In the shelter with the rear-on-exposure, pressure varied from .6 to 1.4 psi.

2 SEP 81 INTERNAL PRESSURE ISOBAR CHART

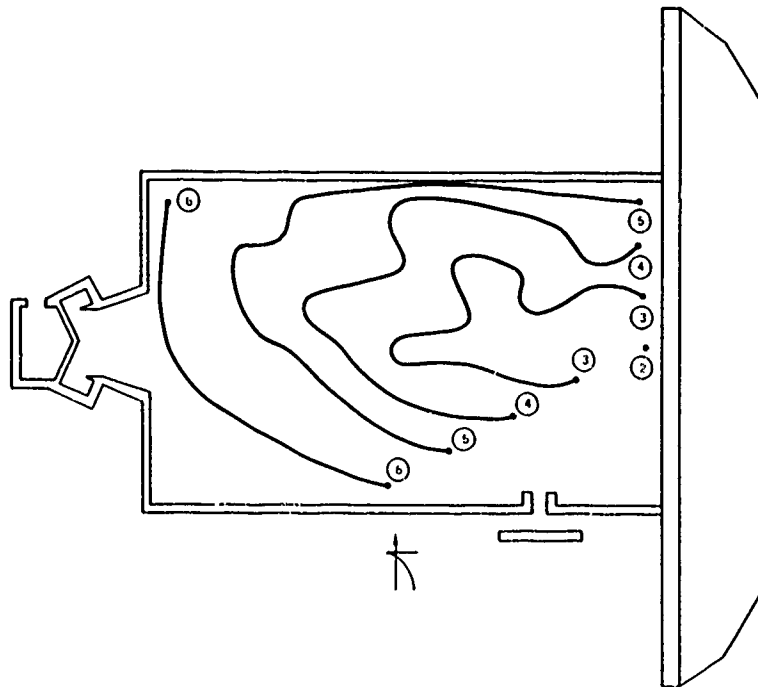
Figure 7

In the shelter with the side on orientation, internal overpressure ranged only from .2 to .6 psi.

2 SEP 81 INTERNAL PRESSURE ISOBAR CHART

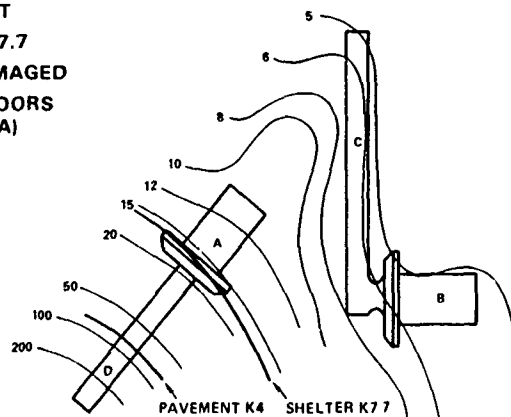
Figure 9

Overpressure readings were higher on this event averaging 17 psi on the front of the shelter with an average impulse of 487 psi-ms. The free-field blast environment for this event is shown in Figure 9.

DISTANT RUNNER 7 OCT 81 BLAST ENVIRONMENT

- 17 PSI AT 460 FEET
- QD K FACTOR OF 7.7
- FRONT DOOR DAMAGED
- EXHAUST PORT DOORS FAILED (SHELTER A)
- NO DAMAGE TO SHELTER WALLS

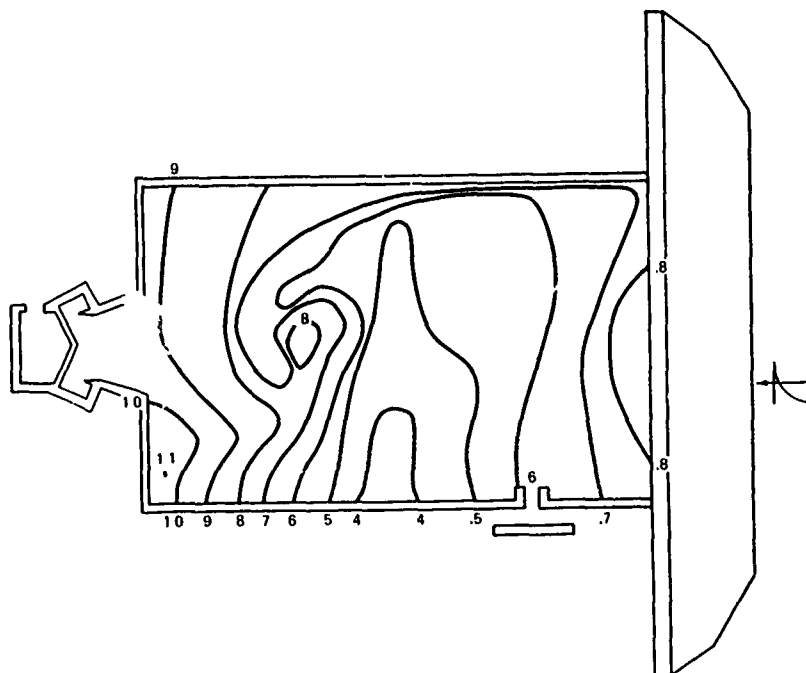
Figure 10

Internal peak positive pressure ranged from .4 to 1.1 psi as shown in Figure 10.

7 OCT 81 INTERNAL PRESSURE ISOBAR CHART

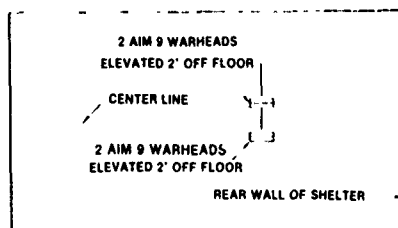
In this test four AIM-9 warheads, 42 lbs net explosive weight, were detonated. This simulated the detonation of a weapons load for an aircraft loaded with air-to-air weapons. As shown in Figure 11 the warheads were located in the shelter as if they were on a plane. Detonating of all warheads was simultaneous.

6 NOVEMBER 1981

- 4 AIM-9 AIR TO AIR MISSILES
(42 LBS NEW)

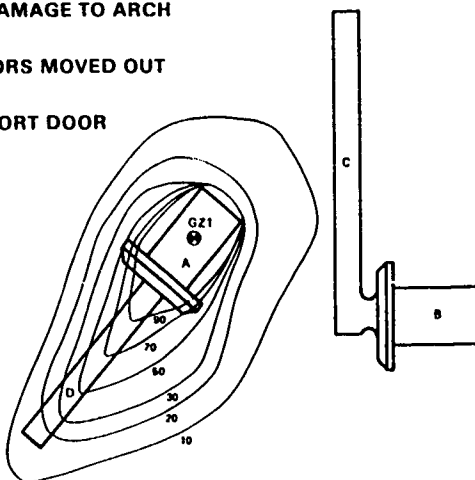
Figure 12

External free field peak overpressure levels are shown on Figure 12.

DISTANT RUNNER 6 NOV 81 BLAST ENVIRONMENT

- MINIMAL DAMAGE TO ARCH WALLS
- FRONT DOORS MOVED OUT 21 FEET
- EXHAUST PORT DOOR INTACT

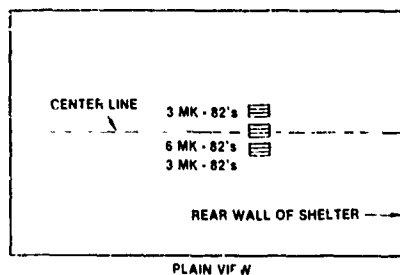
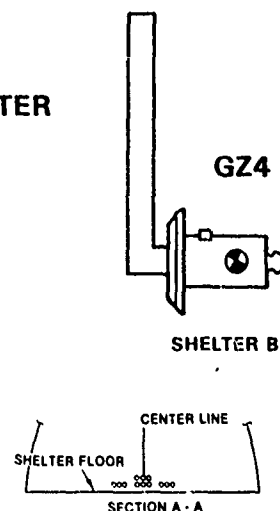
Figure 13

The next internal event in size took place on 28 Oct 1981. In this test 12 MK-82 bombs totaling 2,292 lbs of explosives were detonated inside a shelter. The test configuration is shown in Figure 13.

28 OCTOBER 1981

- 12 MK-82 BOMBS
(2292 LB NEW)
- F101B AIRCRAFT PARKED IN SHELTER

These bombs, which represented a typical air-to-ground sortie load, were placed under a F101B aircraft in a typical load configuration. Actual weapons and a plane were used in order to evaluate debris patterns accurately. The purpose of this event was to investigate the blast pressure and debris hazards created by an accidental explosion in the shelter. This event also served to test a prototype weapons storage vault which had been emplaced inside the shelter. (No damage to the vault or its contents was evident. A final report on the weapons storage vault will be issued by the Air Force Weapons Laboratory.)

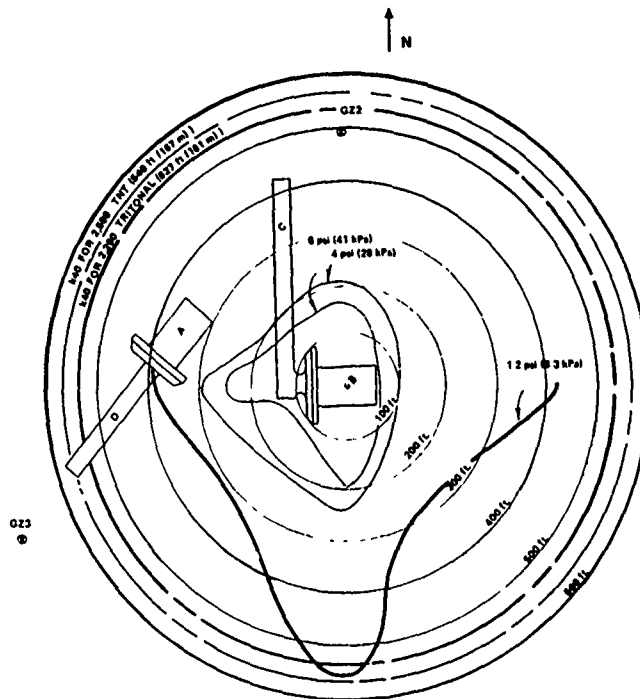
DISTANT RUNNER 28 OCT 81 - BLAST ENVIRONMENT

Figure 14 depicts the free field overpressure from the event. In general, at the same range, higher peak overpressures occurred at the front and sides of the shelter than at the rear. The relatively lower overpressures in the free field to the rear of the shelter were probably due to the protection provided by the massive blast deflector and generator room at the rear of the shelter.

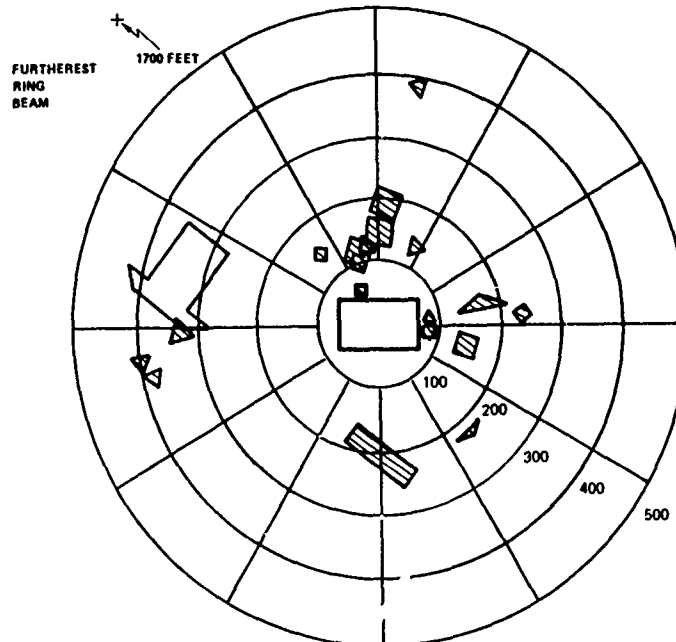
As debris is also a major contributor to QD determination, a debris survey was conducted following the event. As this specific effort will be reported on by Dr. Jerry Ward of NSWC in a separate paper Figure 15 depicting the large debris map is all that will be shown here. The maximum range of 1722 feet of surveyed debris on this event was for a section of ring beam weighing 355 lbs.

DISTANT RUNNER 28 OCT 81 - LARGE DEBRIS MAP

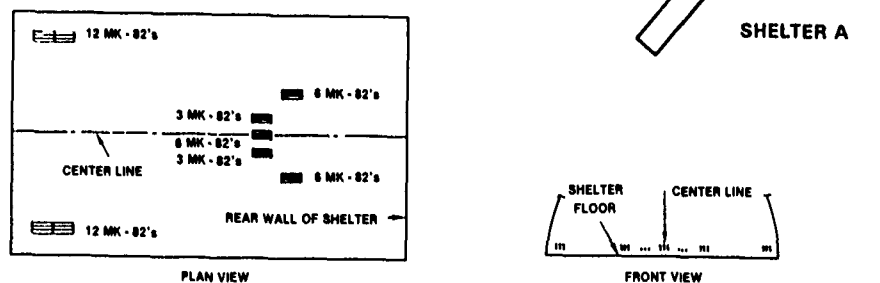
Figure 16

The last internal event occurred on 18 November 1981. In this test 48 MK-82 general purpose bombs totaling 9168 lbs. were detonated inside the remaining shelter. Twelve of the bombs were positioned beneath an F101 aircraft to simulate an aircraft loaded with air-to-ground munitions. The other 36 bombs were positioned near the airplane and at the front corners of the shelter (as shown in Figure 16) to simulate additional weapons also stored within the shelter. Again the purpose of the test was to investigate external blast pressure and debris hazards caused by the accidental simultaneous detonation of explosives stored inside an aircraft shelter.

18 NOVEMBER 1981

- 48 MK-82 BOMBS
(9168 LB NEW)
- F101B AIRCRAFT PARKED IN SHELTER

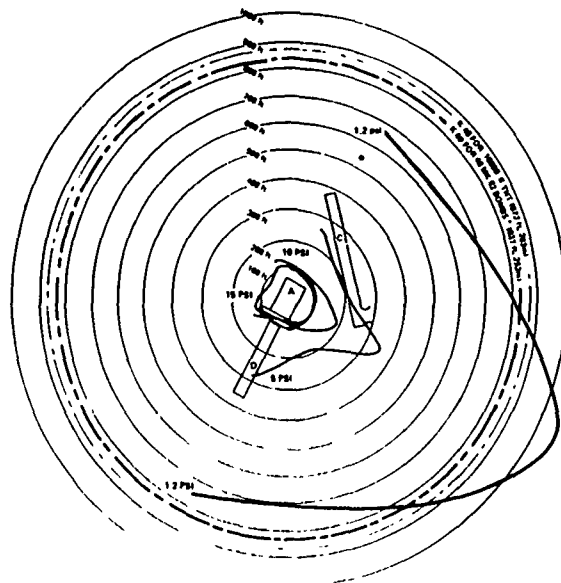
Figure 17 shows four peak pressure isobars for the free field. The 10 psi, 5 psi, and 1.2 psi isobars were not extended to the northwest side of the shelter due to a lack of gages in that area.

DISTANT RUNNER 18 NOV 81 - BLAST ENVIRONMENT

Pressures to the side of the shelter were again generally higher than either to the front or rear. As far as debris was concerned the shelter broke up in many large parts with a fairly uniform pattern. Putting all three internal events together the following conclusions are evident:
